Example of Sediment Removal Site – Paonia Dam and Reservoir

Guardians of the Reservoir Sediment Removal Competition

Location: Paonia Dam and Reservoir are located on Muddy Creek, a tributary of the North Fork Gunnison River in western Colorado

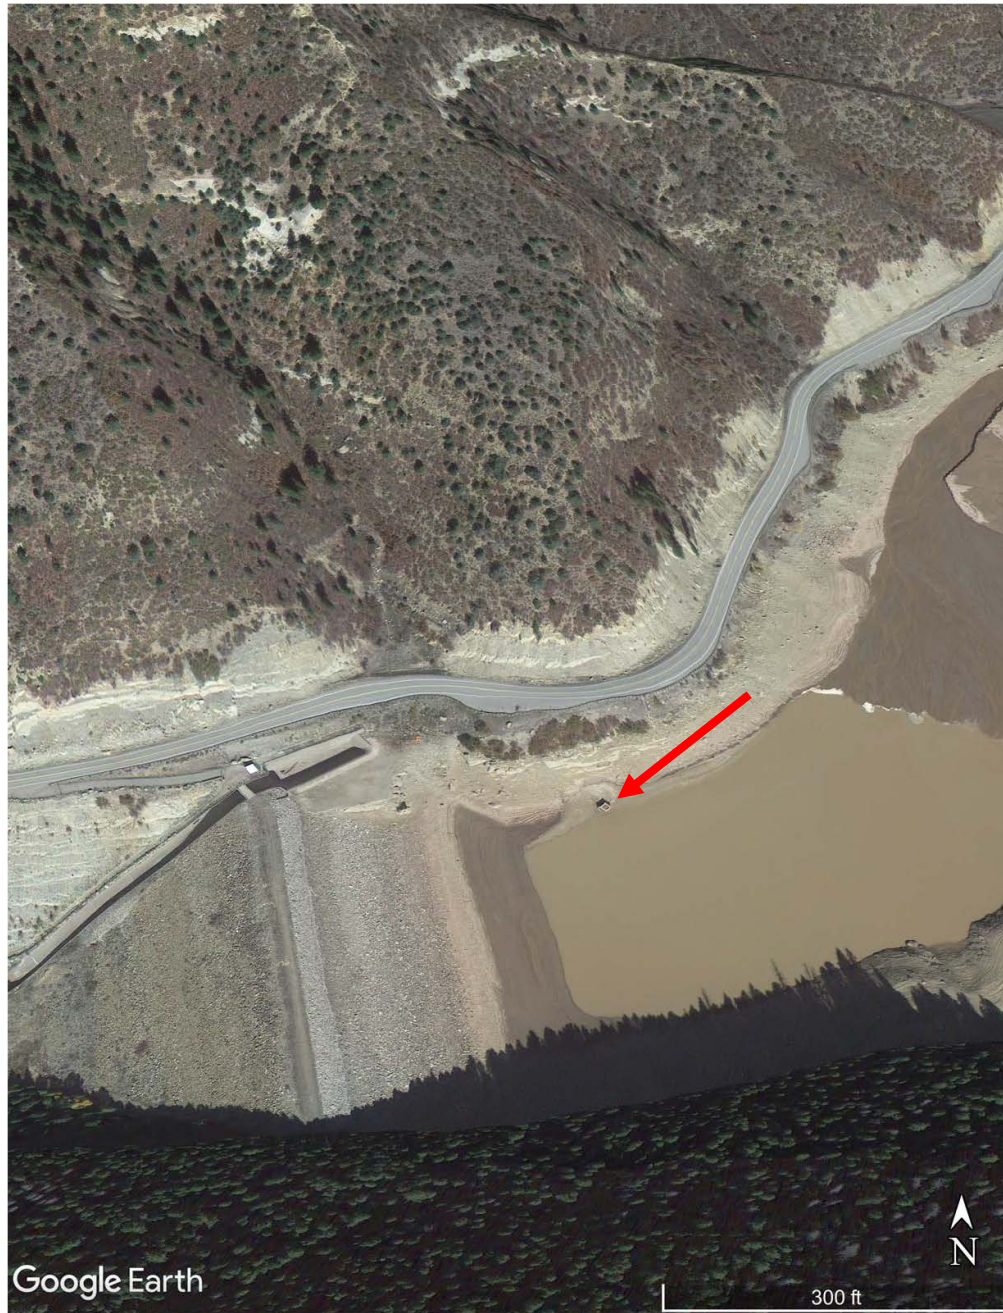
Figure 2.—Aerial view of Paonia Dam and Reservoir. Arrow points to the outlet works intake structure.

the reservoir pool availability would gradually reduce and be completely filled with sediment in another 150 years. Long before sediment levels reach the full pool elevation, reservoir intakes and outlet works will be affected, adversely impacting project operations. Current sediment depths near the intake structure are upwards of 80 feet.

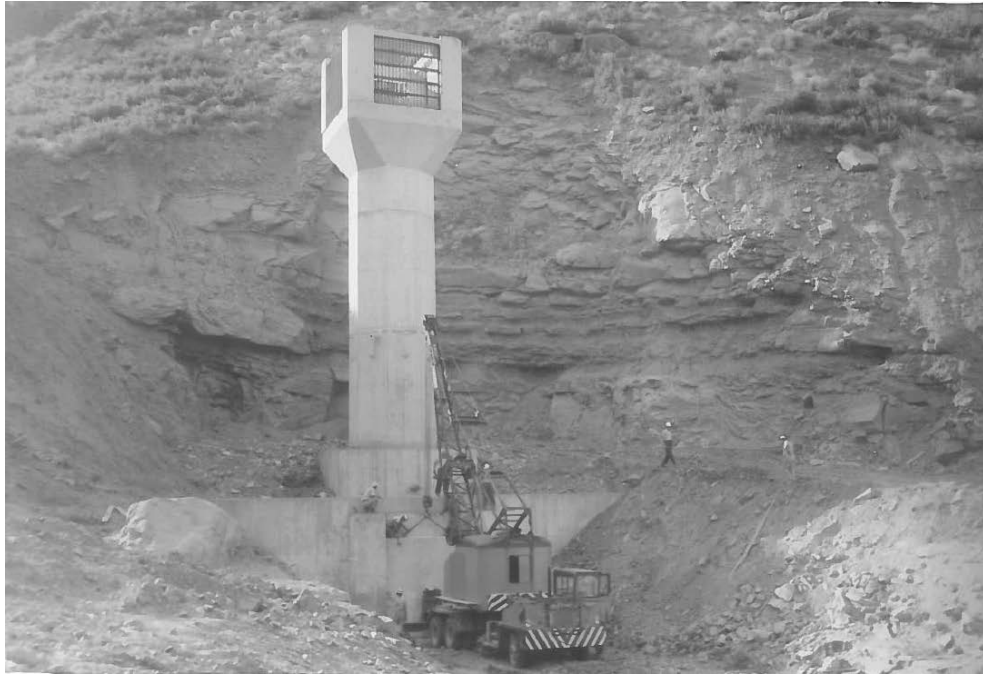
Figure 3.—Original construction photograph of the outlet works intake structure.

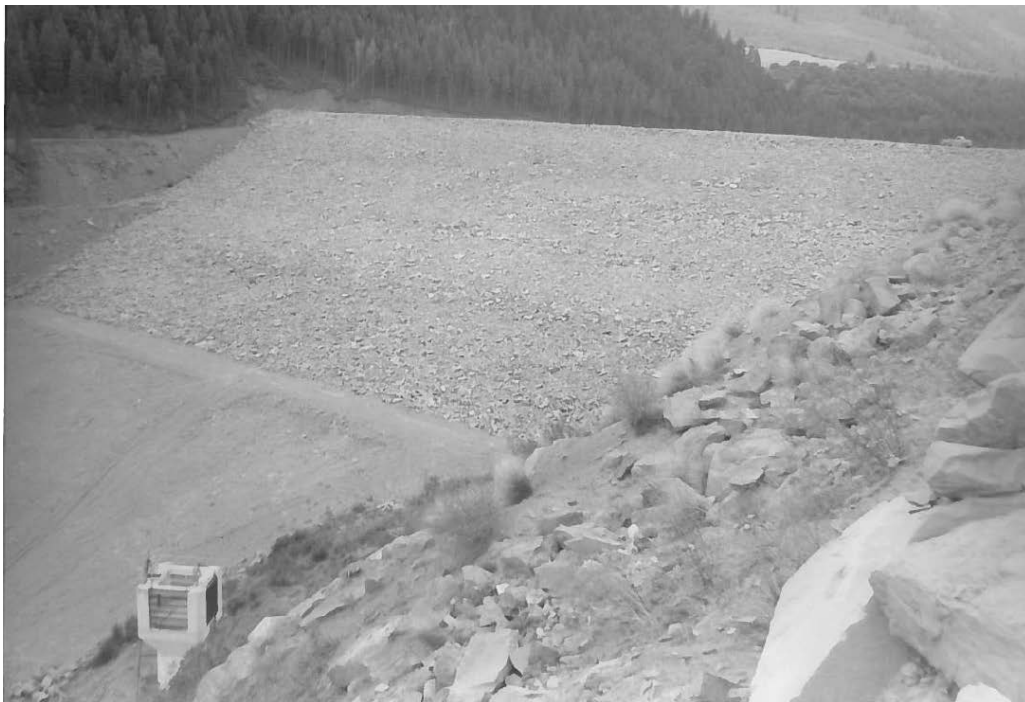
Figure 4.— Original construction photograph of the outlet works intake structure and dam.

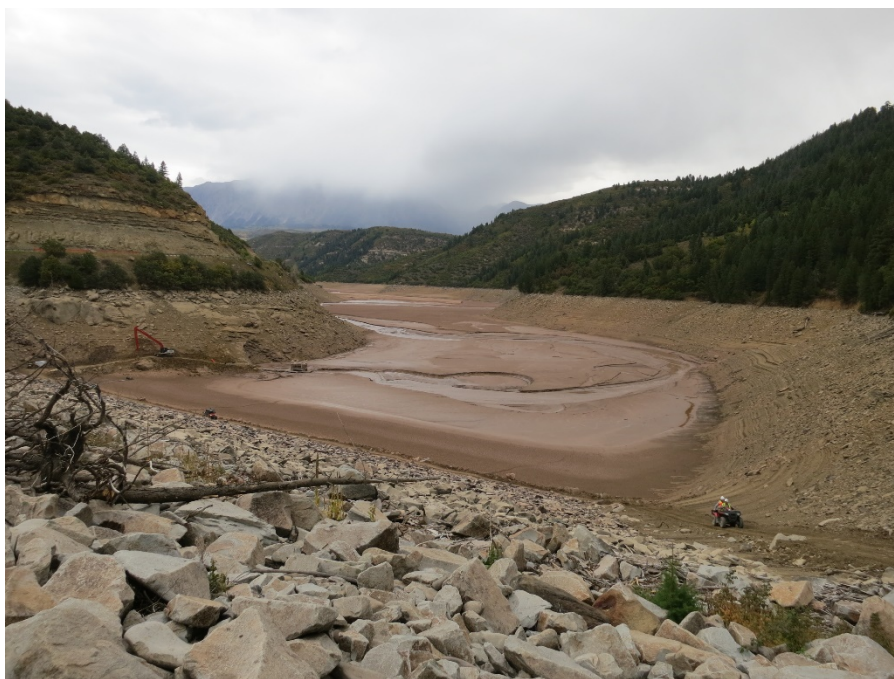
Figure 5.— 2017 photograph looking upstream. Arrow points to the outlet works intake structure.

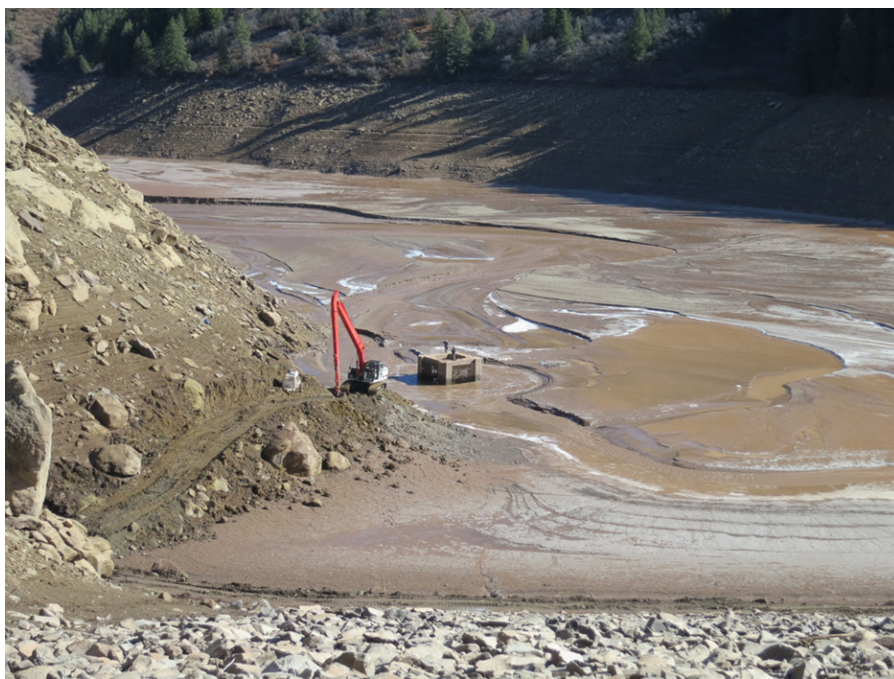
Figure 6.— 2017 photograph showing clearing around intake structure.

Note that the sediment within the existing delta contains a large amount of woody debris. The woody debris is stick or twig size but there is a great deal that accumulates at the intake structure. During the construction of interim repairs of the intake structure in the Fall 2017, the removal of sediment and woody debris build up required two workers working constantly to keep the intake structure clear.

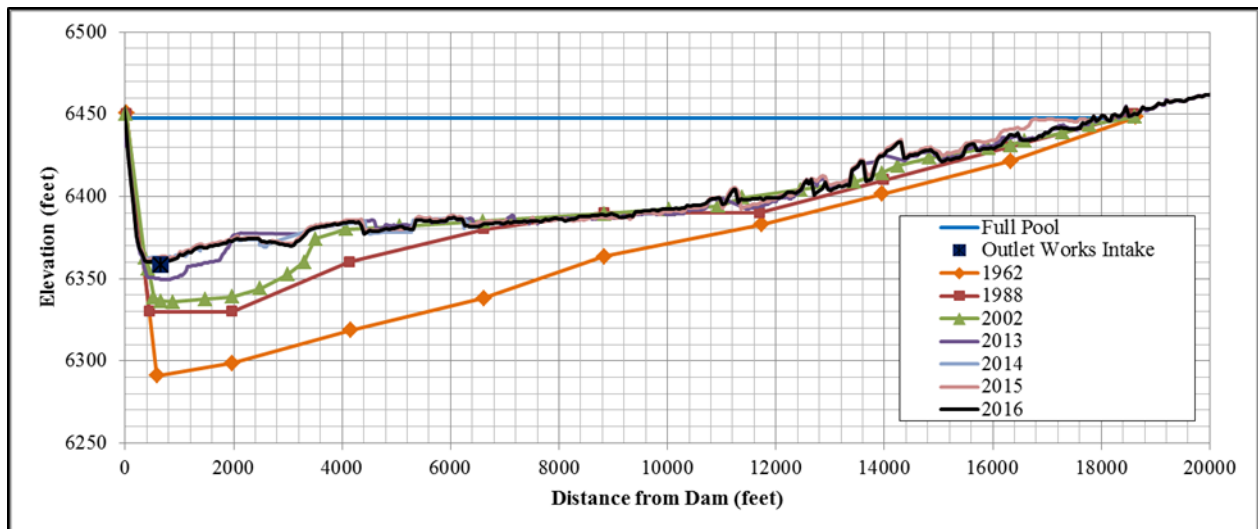
Figure 8.— Profile of Paonia Reservoir showing sediment historical sediment levels.

Amount of Sediment: Approximately 8.75 million cubic yards. Based on the most recent bathymetric survey of the entire reservoir, conducted in June 2016, the estimated average annual rate of sedimentation has been 100 acre-feet per year (161,000 cubic yards per year). Since dam completion in 1962, nearly 26% of the reservoir's original capacity has been lost to sediment deposition. At that rate,

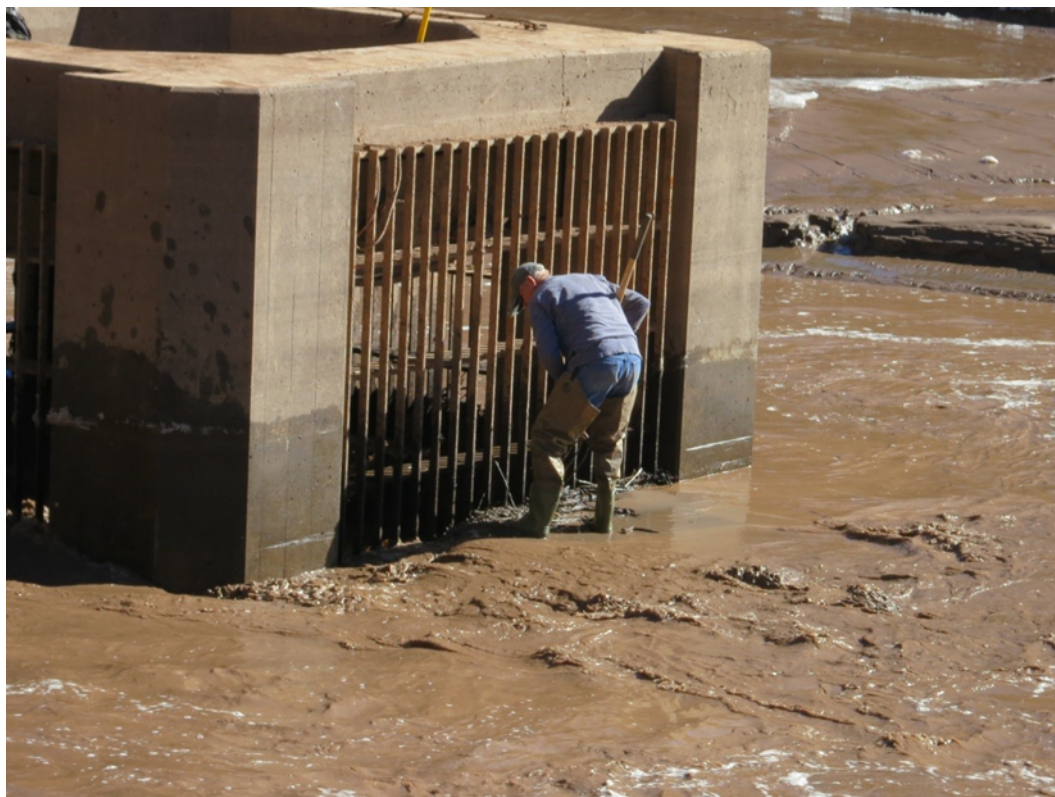
Figure 10.— Clearing sediment and woody debris from the intake structure in 2014.
